5.4 PHOTOGRAPH LOG

BASF Wyandotte

F3-8412-17

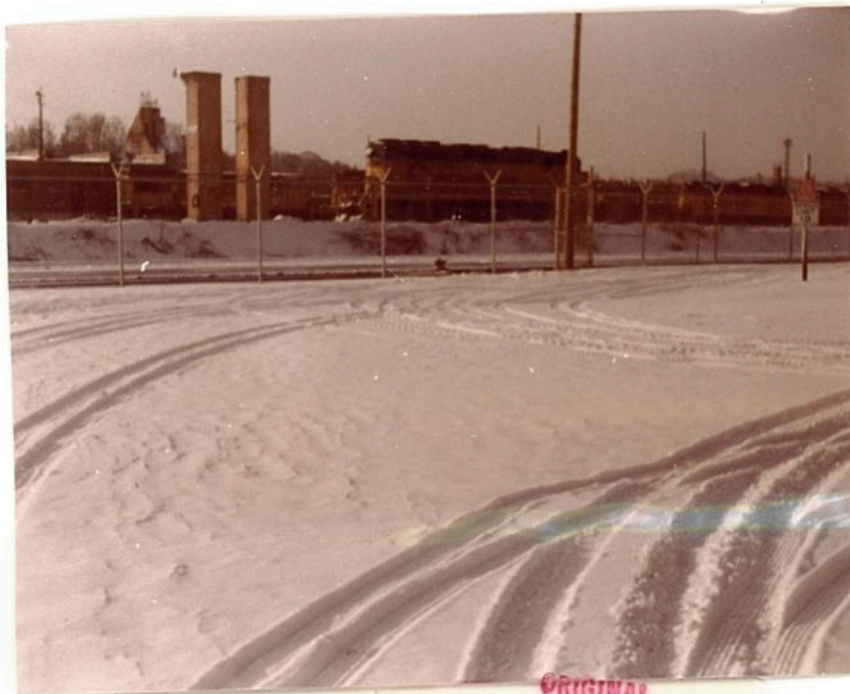
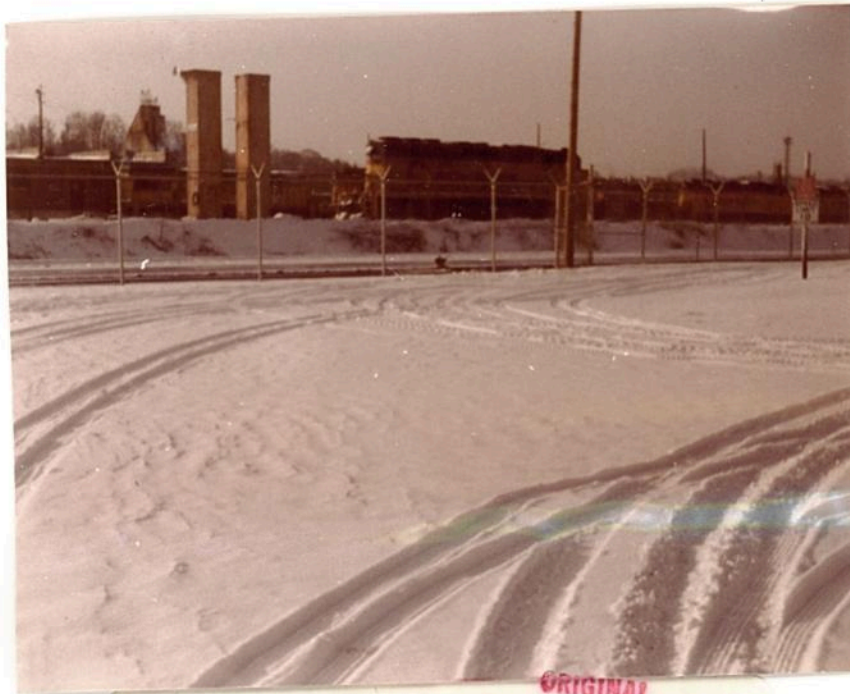
Photo 1 -
Toluene spill area looking southwest.

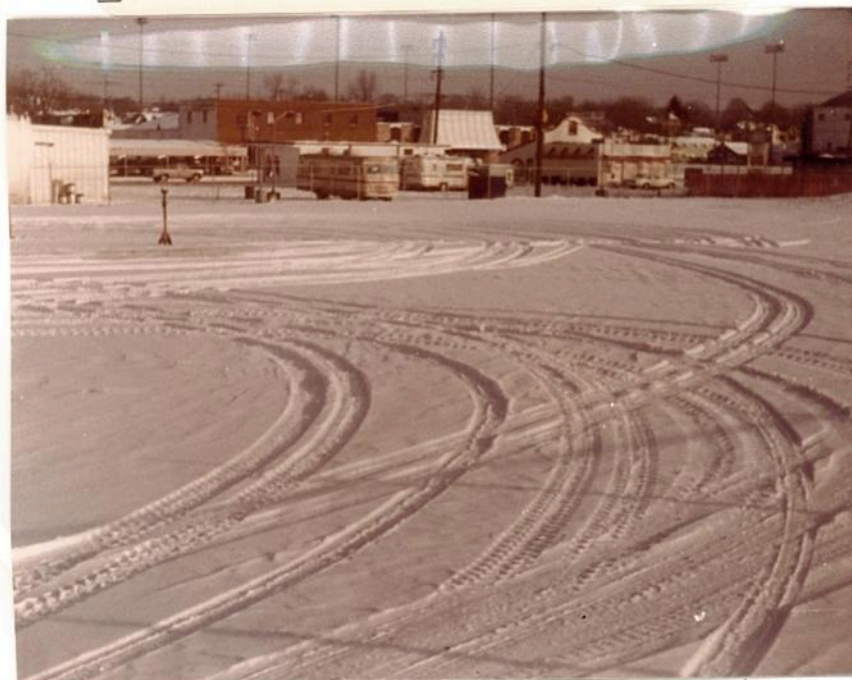
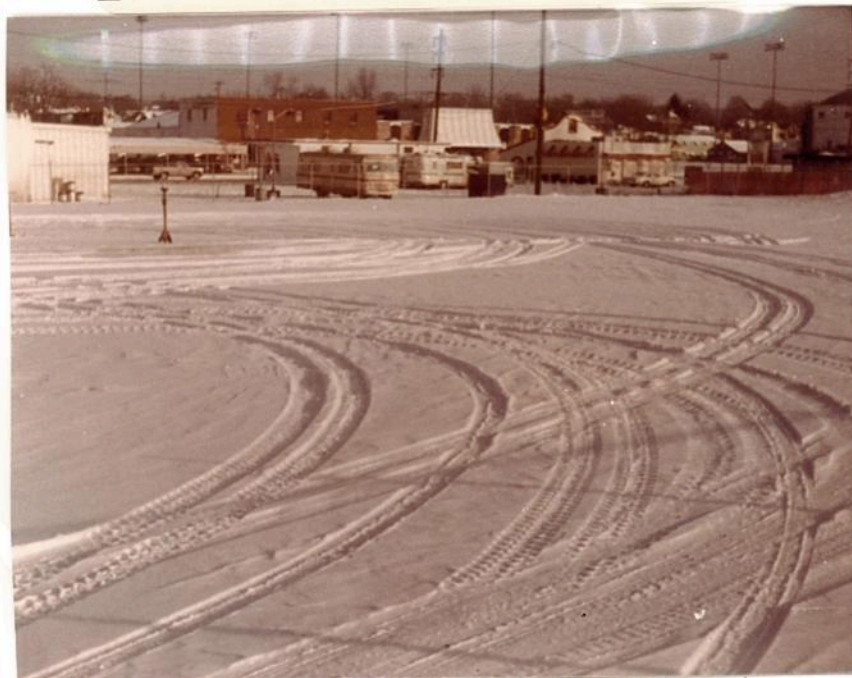
Photo 2 -
Toluene spill area looking north.

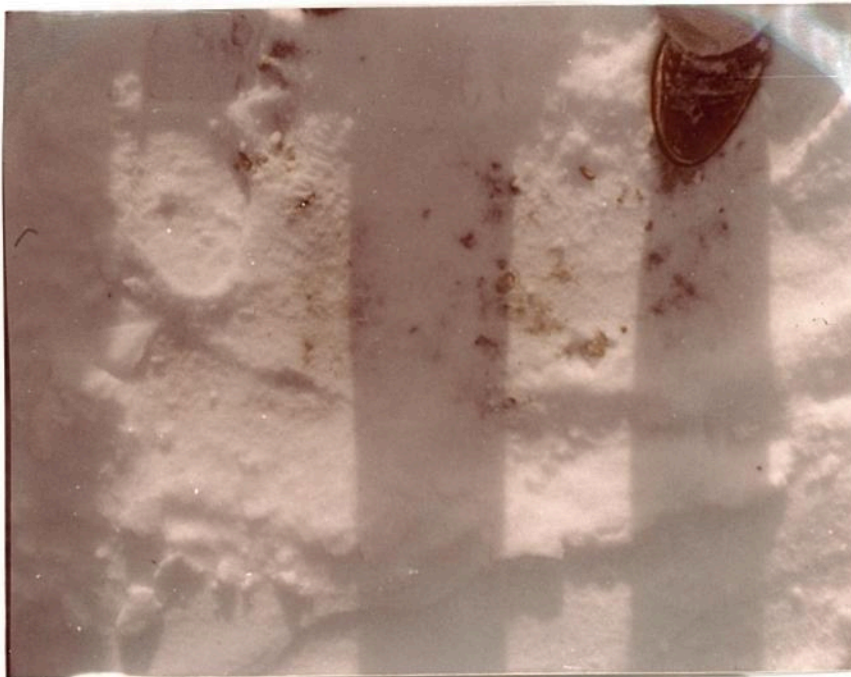
— Photo 3 -
— Toluene spill area and limestone gravel
— surface.

Toluene spill area, Limestone gravel surface.

Photo 3 -
Toluene spill area and limestone gravel
surface.

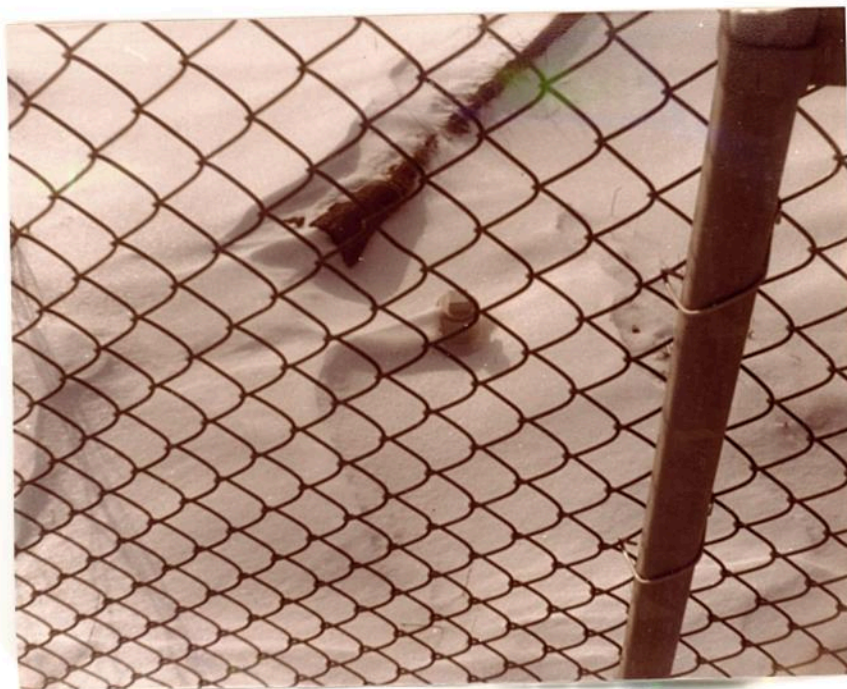
— Photo 4 -
— Toluene spill area and monitoring well.

Toluene Spill area. Monitoring well

Photo 4 -
Toluene spill area and monitoring well.

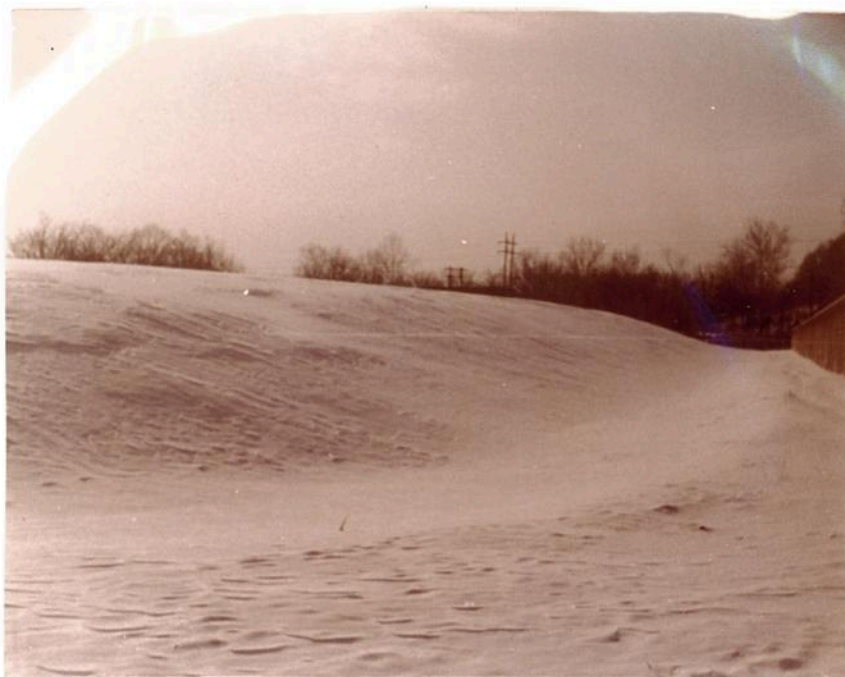
— Photo 5 - 31st Street Landfill. Floodwall
— side of landfill showing surface drainage
— ditch, looking south.

Floodwall side of landfill showing surface
drainage ditch. Looking south

Photo 5 - 31st Street Landfill. Floodwall
side of landfill showing surface drainage
ditch, looking south.

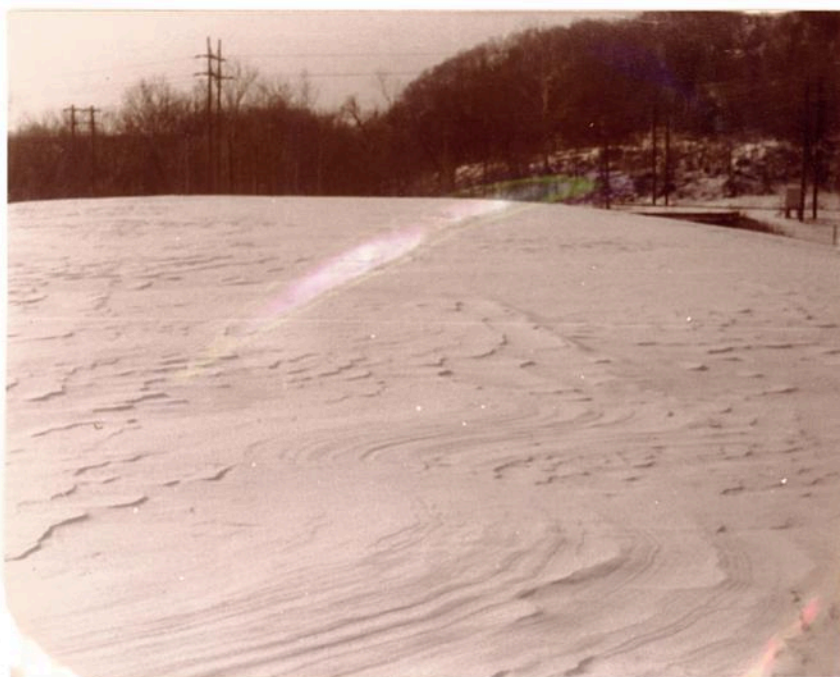
— Photo 6 - 31st Street Landfill
— Crest of landfill, looking south.
—

Crest of landfill. Looking south

Photo 6 - 31st Street Landfill
Crest of landfill, looking south.

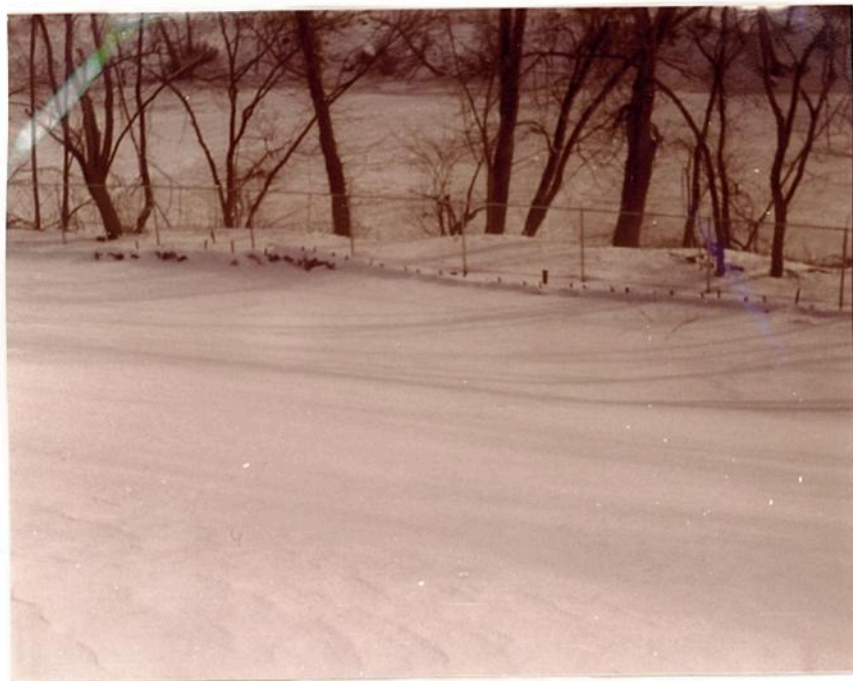
— Photo 7 - 31st Street landfill —
 — Riverside of landfill, viewed from crest. —
 — Looking east. Note hay bales/ —

River side of landfill, viewed from crest.
Looking east. Note hay bales

Photo 5 - 31st Street Landfill
Riverside of landfill, viewed from crest.
Looking east. Note hay bales

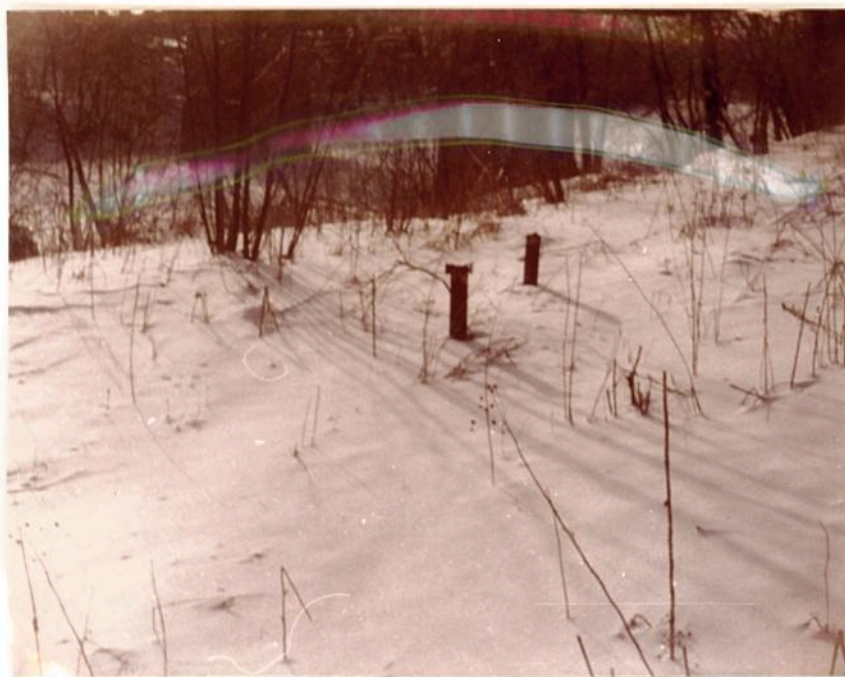
— Photo 8 - 31st Street Landfill. —
 — Monitoring wells, looking south. —

Monitoring wells. Looking south

Photo 8 - 31st Street Landfill.
Monitoring wells, looking south.

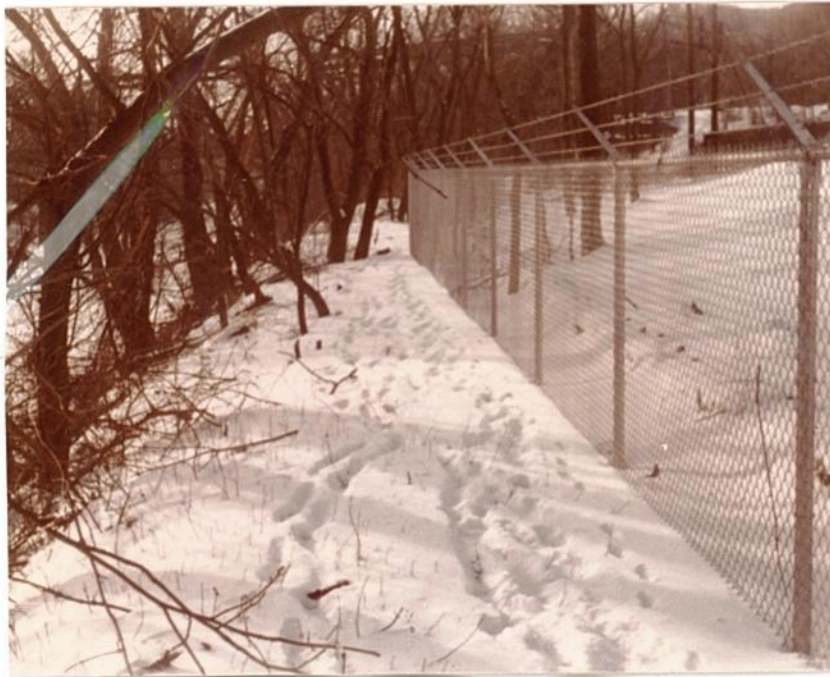
— Photo 9 - 31st Street Landfill ORIGINAL —
 — River side of landfill, looking south. —
 —

River side of landfill. Looking south

Photo 9 - 31st Street Landfill
River side of landfill. Looking south.

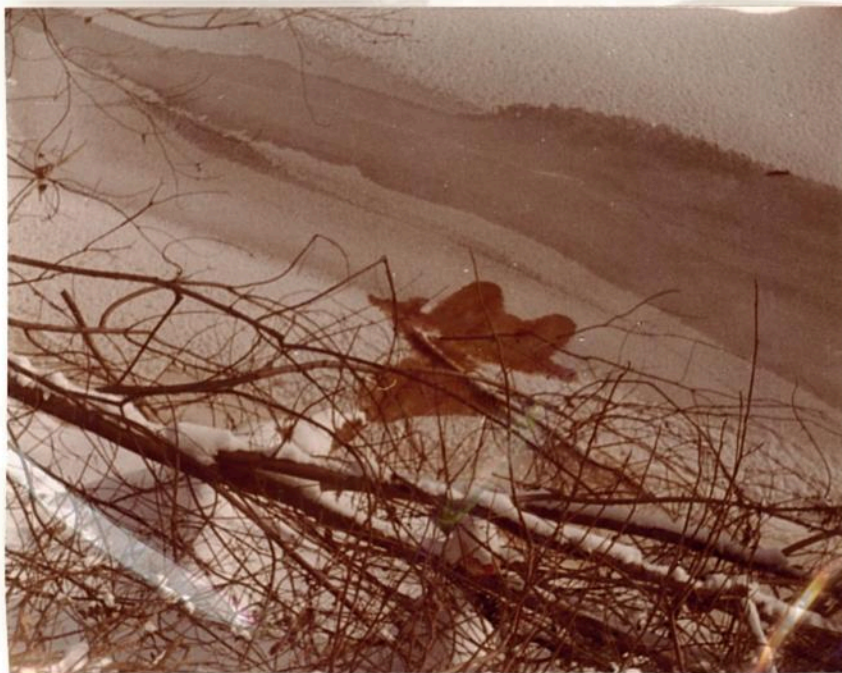
— Photo 10 - 31st Street Landfill —
 — Seepage out onto Guyandotte River, —
 — looking east. —

Seepage out onto Guyandotte River. Looking east

Photo 10 - 31st Street Landfill
Seepage out onto Guyandotte River.
Looking east.
